Nanotechnology and Materials Testing: Using Nanoparticles to Tag Consolidants to Determine Depth of Penetration | 2011-05

Nanotechnology & Materials Testing: Using Nanoparticles to Tag Consolidants to Determine Depth of Penetration

Grant No. MT-2210-10-NC-03

Organization: New York State Office of Parks,
Recreation & Historic Preservation

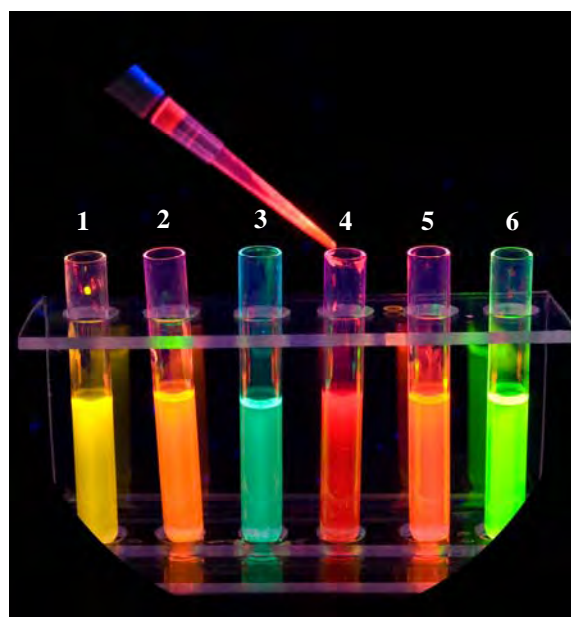
Image 1. Solvent—Nanoparticle Compatibility Test

A range of quantum dots in xylene.
0.1µL of quantum dot in 1ml of xylene.

- 1: Evident T2 Evi Dot™ - Hops Yellow
- 2: Evident T2 Evi Dot™ - Birch Yellow
- 3: Evident T2 Evi Dot™ - Adirondack Green
- 4: Evident T2 Evi Dot™ - Maple Red Orange
- 5: Evident T2 Evi Dot™ - Fort Orange
- 6: Evident T2 Evi Dot™ - Catskill Green

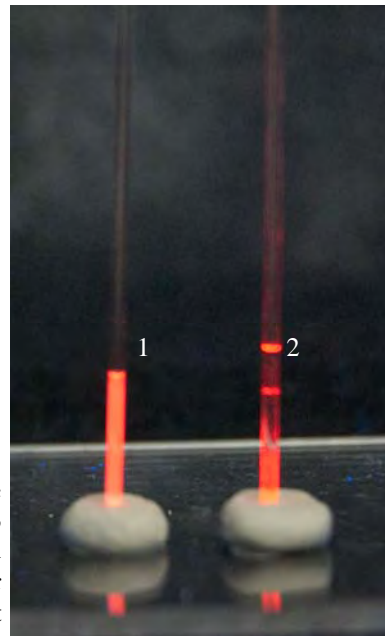
Image 2. Solvent—Nanoparticle Compatibility Test 1.3
eBioscience eFluor™ 625 in
1. xylene, 2. water
350nm UV light

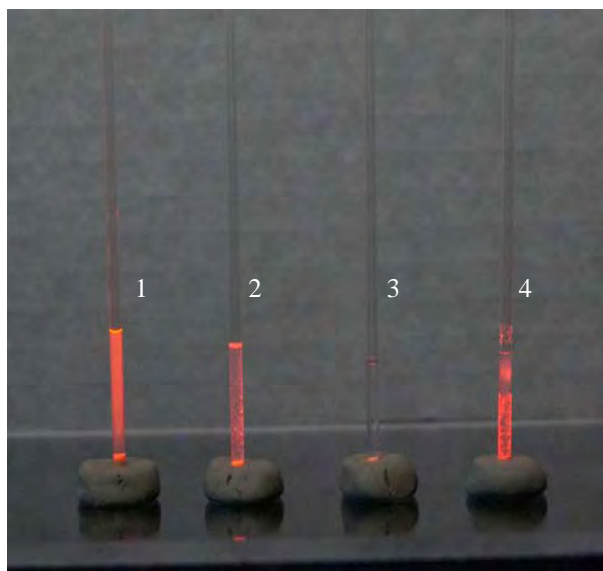
Image 3.
Solvent—Nanoparticle Compatibility Test 1.3
Evident T2 Evi Dot™ Maple Red-Orange in
1. xylene, 2. ethanol, 3. acetone, 4. water
350nm UV light

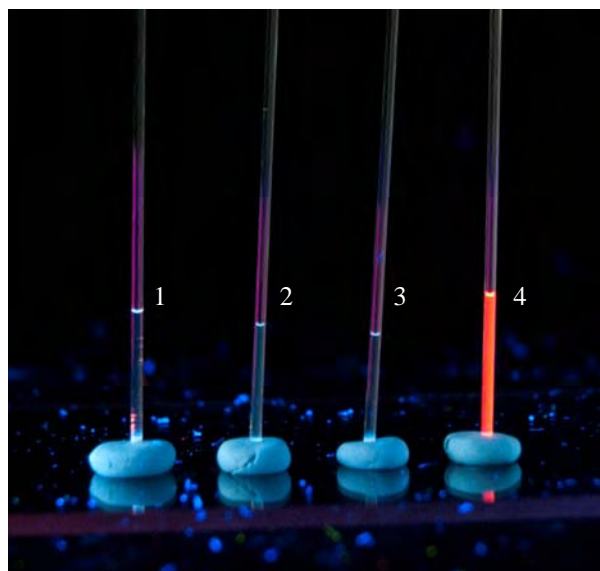
Image 4.
Solvent—Nanoparticle Compatibility Test 1.3
Sun Innovations™ YVE1005 in
1. xylene, 2. ethanol, 3. acetone, 4. water
325nm UV light

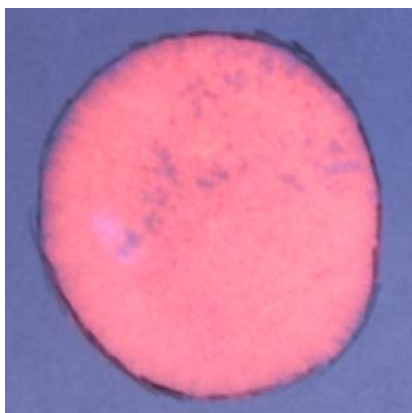
Image 5.
Solvent—Nanoparticle Compatibility
Test 1.4
 Evident T2 Evi Dot™
 Maple Red-Orange in xylene
 350nm UV light

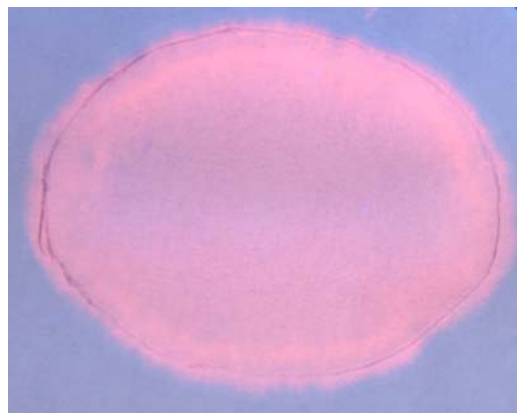
Image 6.
Solvent—Nanoparticle Compatibility
Test 1.4
 Sun Innovations™
 YVE1005 in water
 325nm UV light

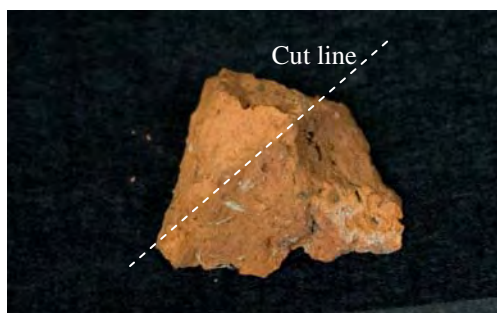
Image 7. Nanoparticle-Matrix Compatibility Test

Evident T2 EviDot™ Maple Red-Orange applied to brick sample under halogen light.

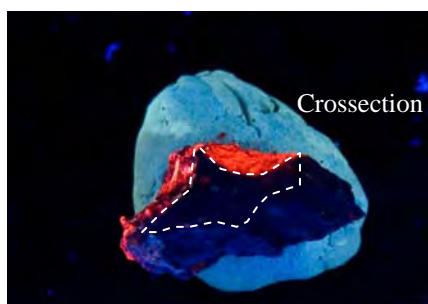
Image 8. Nanoparticle-Matrix Compatibility Test Crossection

Evident T2 EviDot™ Maple Red-Orange applied to brick sample under ultraviolet light. The fluorescing nanoparticles did not penetrate through the sample indicating a lack of compatibility with the matrix.

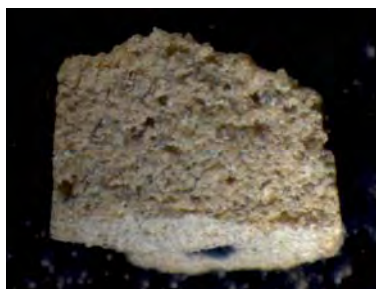
Image 9. Nanoparticle-Matrix Compatibility Test

Evident T2 EviDot™ Maple Red-Orange applied to mortar sample under halogen light.

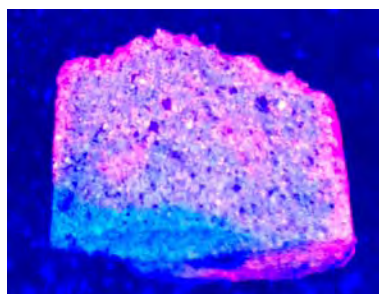
Image 10. Nanoparticle-Matrix Compatibility Test Crossection

Evident T2 EviDot™ Maple Red-Orange applied to mortar sample under ultraviolet light. Fluorescing nanoparticles throughout indicate a compatibility with the mortar.

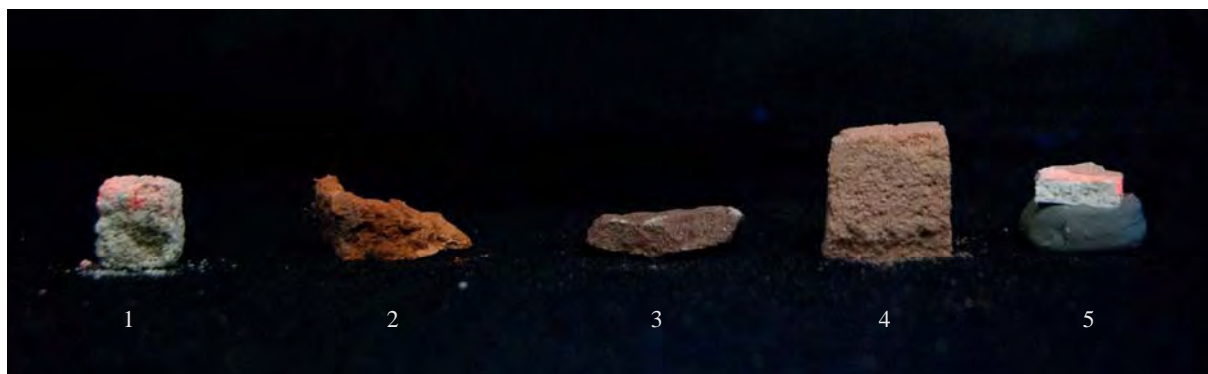
Image 11.
Nanoparticle– Matrix Compatibility Test 2.1
eBioscience eFluor™625 in xylene
under uv (350nm) & halogen light
1.Mortar, 2.brick, 3.sandstone, 4.adobe, 5.gesso

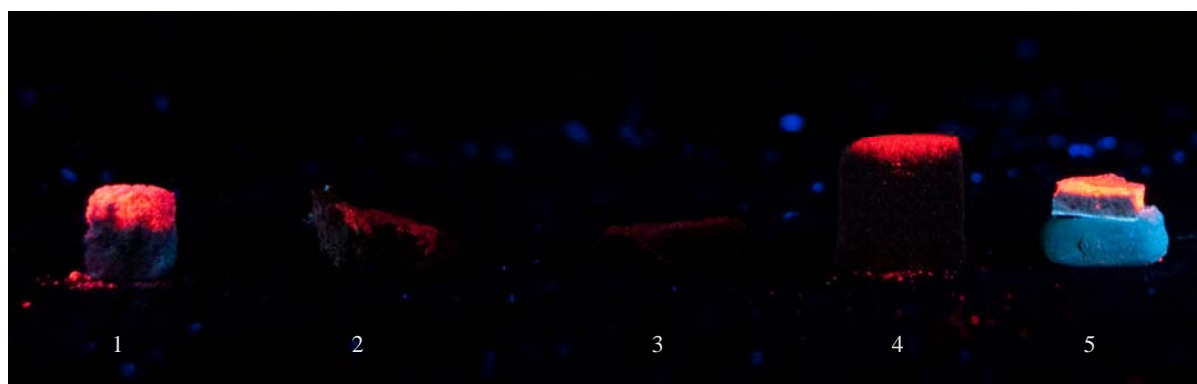
Image 12.
Nanoparticle– Matrix Compatibility Test 2.1
eBioscience eFluor™625 in xylene
under uv (350nm)
1.Mortar, 2.brick, 3.sandstone, 4.adobe, 5.gesso

²It was theorized that the outer shell of the nanoparticle was effected by the electrostatic forces of the matrix. An attempt was made to remove the outer shell of the nanoparticle to reduce the electrostatic forces. However, this process quenched the nanoparticles.

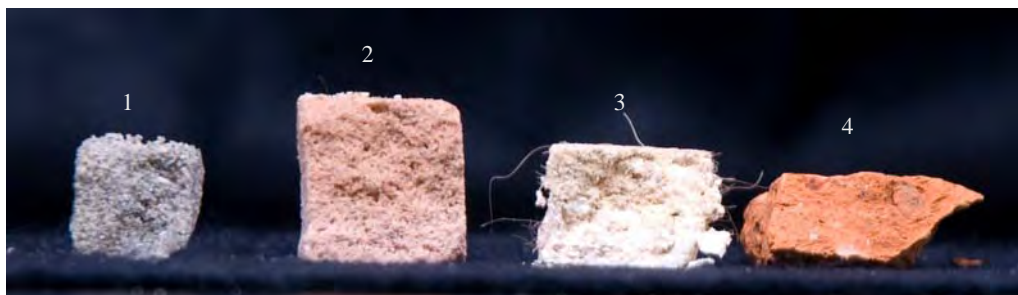
Image 12.
Nanoparticle– Matrix Compatibility Test 2.1
Sun Innovations™ YVE1005 in water
under halogen light
1.mortar, 2.adobe, 3. plaster 4.brick

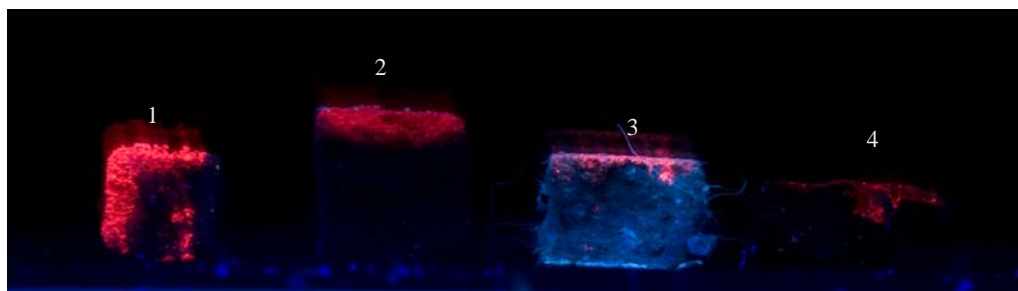
Image 13.
Nanoparticle– Matrix Compatibility Test 2.1
Sun Innovations™ YVE1005 in water
under UV light

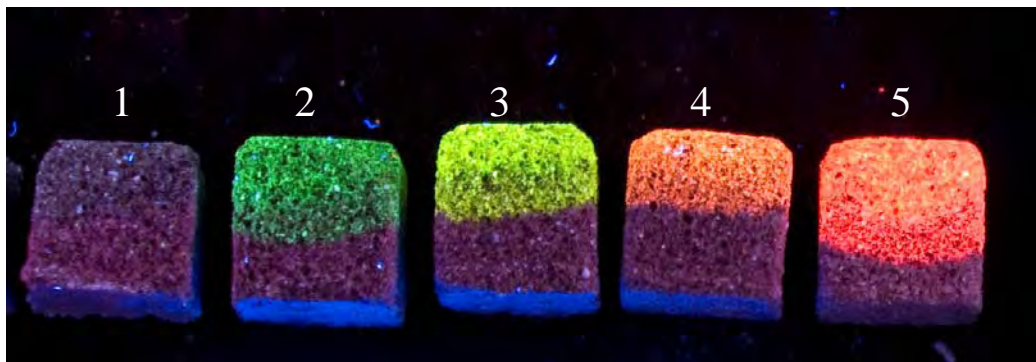
Image 9.

Evident T2 Evi Dots™ in xylene applied to mortar cube observed under UV (350nm)

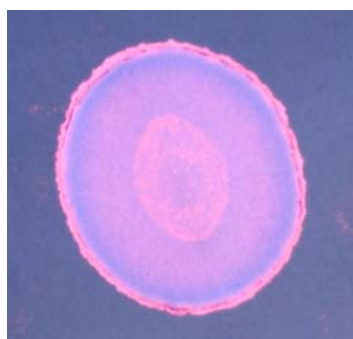
Image 9. Nanoparticle-Consolidant Compatibility –Filter Paper Test

Sun Innovations YVE1005™ & Isinglass applied to filter paper under ultraviolet light (325nm).

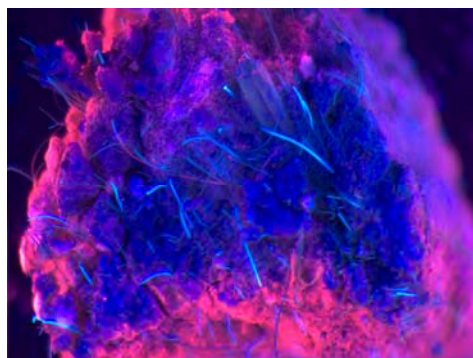
Image 11.
**Nanoparticle/Consolidant–
Matrix Compatibility Test**
Evident T2 EviDot™ Maple Red-Orange &
Paraloid B72 applied to a plaster sample un-
der ultraviolet light (350nm).

- The Evident T2 EviDot™ Maple Red-Orange & Paraloid B72 successfully penetrated all of the selected matrices without separating out of solution. The nanoparticles traveled with the Paraloid B72. This was also observed with Lascaux P550, PVA- AYAA and cyclododecane.
- The Sun Innovations™ YVE1005 and Isinglass successfully penetrated all of the selected matrices, except sugar cubes, without separating out of solution. The nanoparticles traveled with the isinglass. This was also observed with dilute solutions of Ethulose. Sugar cubes were not tested with aqueous consolidants.

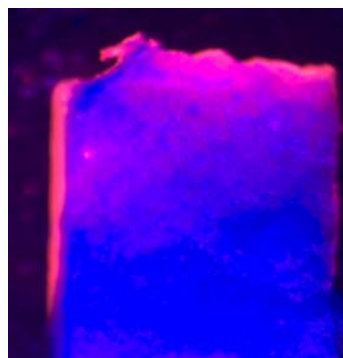
Image 12.
**Nanoparticle/Consolidant–
Matrix Compatibility Test**
Evident T2 EviDot™ Maple Red-Orange &
Paraloid B72 applied to a marble sample un-
der ultraviolet light (350nm).

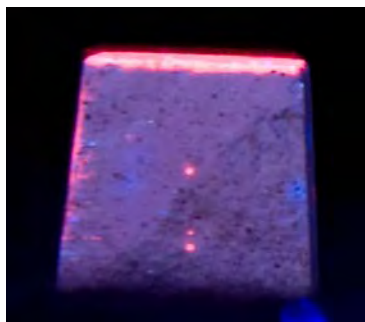
Image 13.
**Nanoparticle/Consolidant– Matrix
Compatibility Test**
Evident T2 EviDot™ Maple Red-Orange
& Prosoco OH100 applied to a mortar cube
under ultraviolet light (350nm).

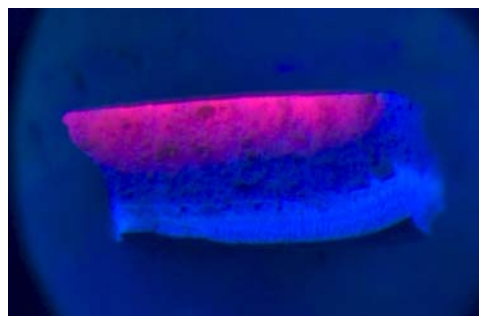
Image 14.
**Nanoparticle/Consolidant– Matrix Com-
patibility Test**
Sun Innovations™ YVE1005 & Isinglass
applied to a gesso sample under ultraviolet
light (325nm).

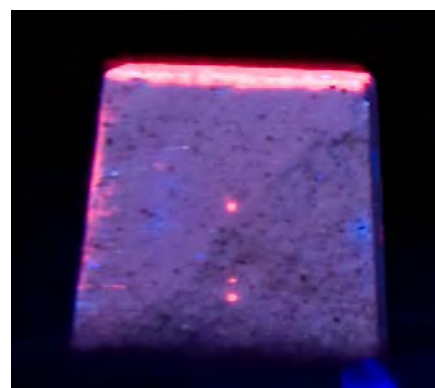
Images 26.
Nanoparticle/Consolidant– Matrix Compatibility Test
Evident T2 Evi Dot™ Maple Red-Orange & Prosoco OH100 applied to a mortar cube under UV light. The nanoparticles remained on the surface.

Weakly bound mortar cubes were treated with nanoparticle tagged Prosoco OH100. The entire sample was saturated with the solution. Once the sample had dried the sample was cut to reveal the cross section and examined under UV light. The UV examination revealed that the nanoparticles failed to penetrate the sample collecting on the surface of the sample. (Note in the sample shown to the right—the isolated nanoparticles in the center of the cube were a result of transfer during crossectioning).

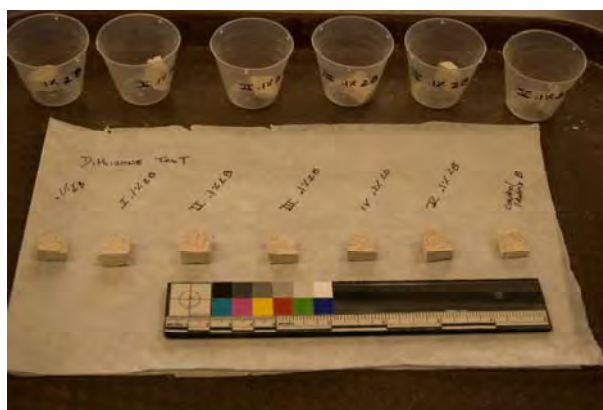
Images 27.
Before Dithizone Reagent Test
Evident T2 Evi Dot™ Maple Red-Orange & Prosoco OH100 applied to a mortar cube. The samples were cut to reveal the crosssection. The control sample on the far right was not treated with OH100.

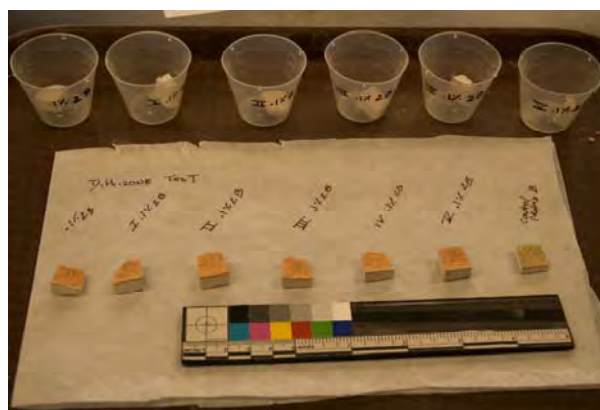
Images 28.
After Dithizone Reagent Test
The Dithizone Reagent turned the samples pink/orange indicating the presence of organic tin compounds. This confirms the presence of the Prosoco OH100 consolidant within the cube.

The samples were then treated with Dithizone Reagent. The reagent identified the presence of organic tin compounds throughout the sample indicating the consolidant did penetrate the sample.

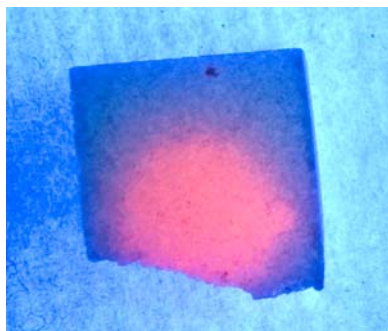
Image 15.
**Nanoparticle/Consolidant–
Matrix Compatibility Test**
Evident T2 EviDot™ Maple Red-
Orange & Paraloid B72 applied to a
sugar cube under ultraviolet light.

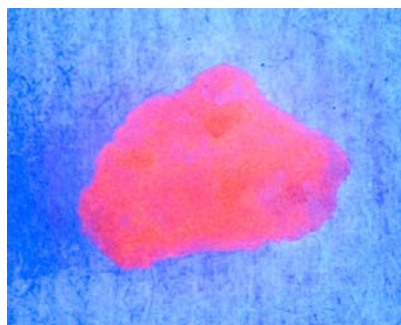
Image 16.
**Nanoparticle/Consolidant–
Matrix Compatibility Test**
Evident T2 EviDot™ Maple Red-
Orange & Paraloid B72 applied to a
sugar cube under ultraviolet light.
Unconsolidated material has been
removed. Entire sample fluoresces.

The treated sample was immersed in distilled water. The consolidated portion of the sugar cube was then removed and allowed to dry. The water was retained and examined under UV light. No nanoparticles were detected in the water. The dry sample was then examined and photographed under UV light. The entire consolidated sample fluoresced indicating the presence of nanoparticle.

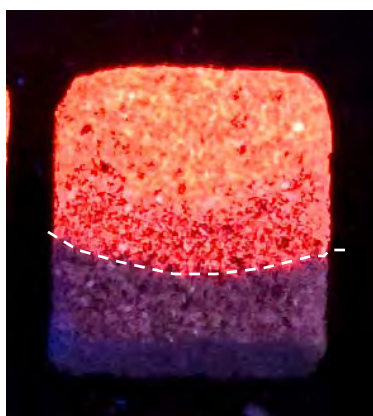
Image 17.
Nanoparticle/Consolidant–
Matrix Compatibility Test
Side view—Before

Evident T2 EviDot™ Maple Red-Orange & Paraloid B72 applied to a mortar cube under ultraviolet light. The unconsolidated material is below the dashed line.

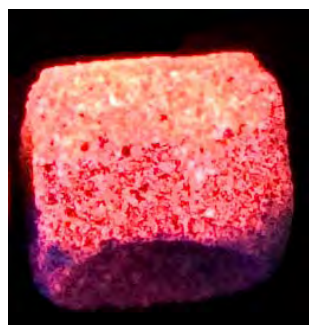
Image 18.
Nanoparticle/Consolidant–
Matrix Compatibility Test
Side view—After mechanical
abrasion

Evident T2 EviDot™ Maple Red-Orange & Paraloid B72 applied to a mortar cube under ultraviolet light. The unconsolidated material has been removed creating a hollowed out pocket at the bottom of the sample.

The tagged sample was then mechanically abraded to remove all of the unconsolidated material. The unconsolidated material that was removed was examined under UV light. No nanoparticles were detected. The entire consolidated sample fluoresced indicating the presence of nanoparticle throughout the entire sample.

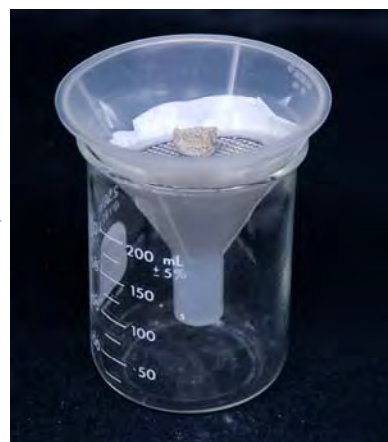
Image 18. Acid Digestion Set Up

The tagged sample was then placed on a wire mesh screen set over filter paper in a funnel. The bottom of the funnel was plugged. The funnel was then filled with a mild acetic acid solution. The unconsolidated material was dissolved by the acid falling through the wire screen to be trapped by the filter paper. The funnel was unplugged allowing the acetic acid to drain. The consolidated sample and the 'fines' (retained unconsolidated material) were allowed to dry and examined under UV light.

No nanoparticles were detected in the fines. The entire consolidated sample fluoresced indicating the presence of nanoparticles throughout the entire sample.

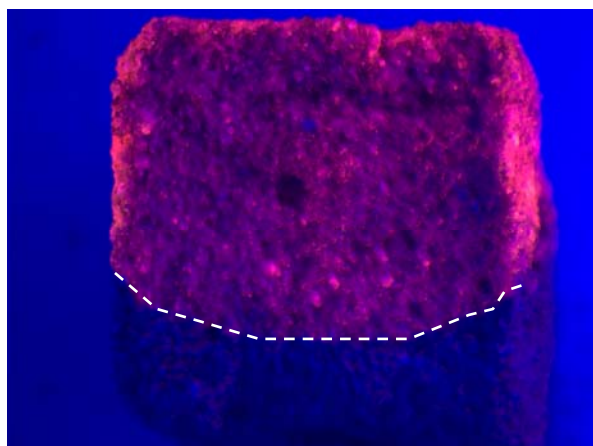
Image 19. Nanoparticle/Consolidant–Matrix Compatibility Test

Evident T2 EviDot™ Maple Red-Orange & Paraloid B72 applied to a mortar cube under ultraviolet light. The unconsolidated material is below the dashed line.

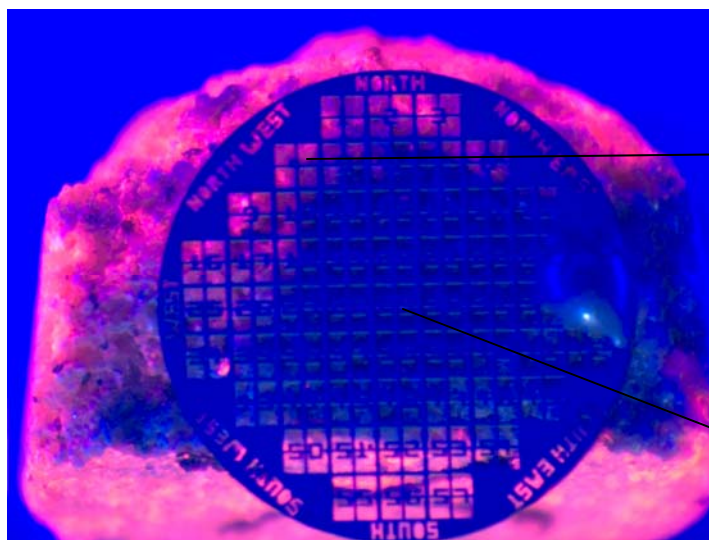
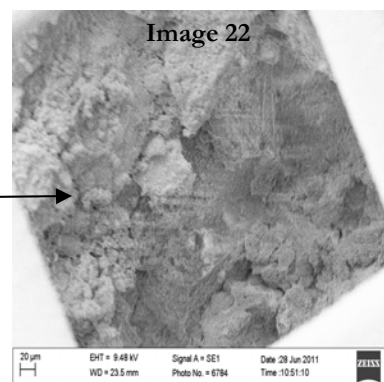
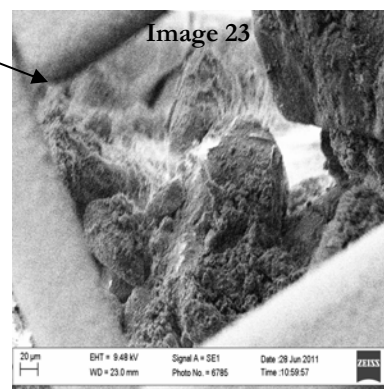
Images 21, 22 & 23.
Nanoparticle/Consolidant– Matrix
Compatibility Test SEM

Sun Innovation™ YVE1005 & Isinglass applied to a mortar cube with SEM grid under ultraviolet light. Image 21: SEM grid location NW4. Note fine cross-hatched fibrils of isinglass. Image 22: SEM grid location 29 no isinglass detected.

Isinglass was detected in the fluorescing coordinates but not in the other coordinates.

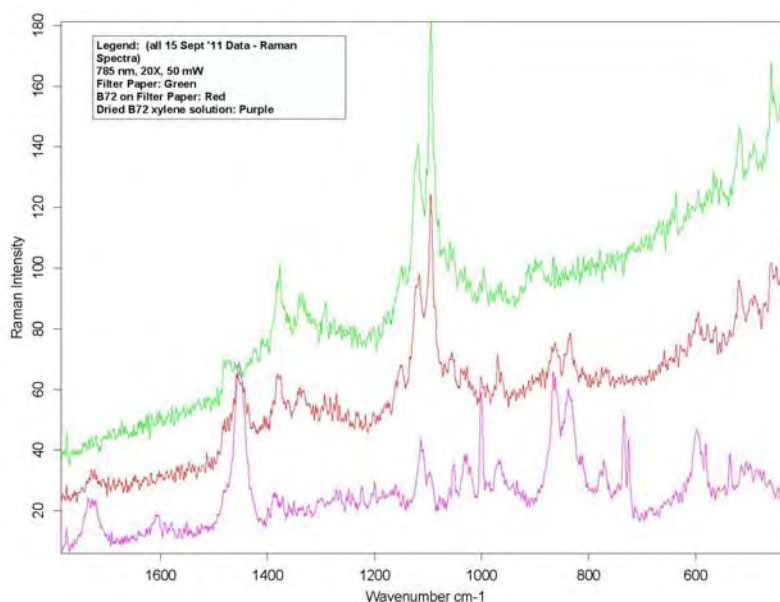
Graph 2.

Detection of Filter Paper (blue) outside fluorescing area, Paraloid B72 (red) detected just within boundary of fluorescing area & Paraloid B72 (red) detected within boundary of fluorescing area.

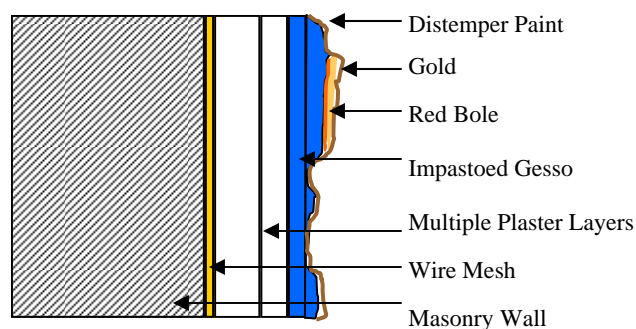
Diagram 1
Cole Hall Mural Section

The Coe Hall mural, painted by Robert Winthrop Chanler, Planting Fields, NY State Park, began flaking soon after its completion. In addition to unstable environmental conditions, Chanler's construction method may be partly responsible for the advanced deterioration. The mural's primary support is a masonry wall covered with wire mesh supporting multiple layers of plaster. On top of the finish plaster layer is a layer of heavy gesso with impasto strokes. Select areas have been prepared for gold leafing with a layer of red bole. Finally the surface features a thin layer of distemper based paint.

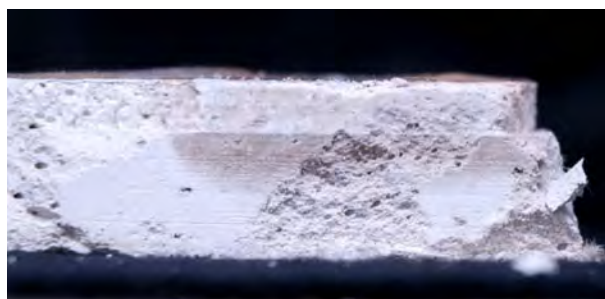
Image 2. Crosssection
Mural mockup treated with Paraloid B72 tagged with Evident T2 Evi Dot™ Maple Red-Orange under halogen light. 100x magnification

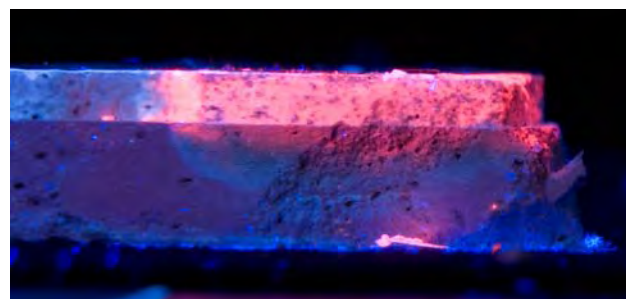
Image 3. Crosssection
Mural mockup treated with Paraloid B72 tagged with Evident T2 Evi Dot™ Maple Red-Orange under 350nm UV light. 100x magnification

The nanoparticles proved successful in penetrating through a complex multi-layer structure. The tagged Paraloid B72 (Image 3.)penetrated through the paint, gesso and plaster layers to reach the sheetrock foundation of the mock-up. The isinglass penetrated through the paint, gesso and plaster layers but only beginning to penetrate the sheetrock foundation layer. Since in each case a controlled amount of consolidant was applied to the mock up this indicated that the Paraloid B72 was more effective at penetrating the structure.

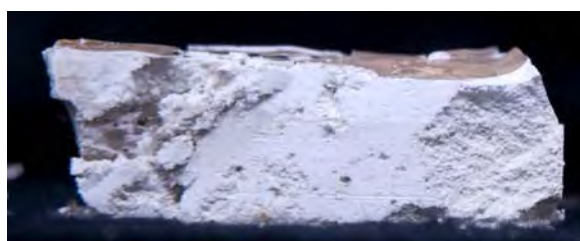
Image 4. Crosssection
Mural mockup treated with Isinglass tagged with Sun Innovations™ YVE1005 under halogen light. 100x magnification

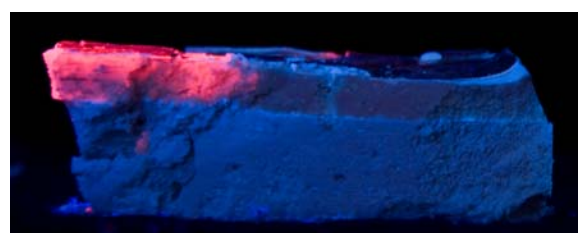
Image 5. Crosssection
Mural mockup treated with Isinglass tagged with Sun Innovations™ YVE1005 under 325nm UV light. 100x magnification

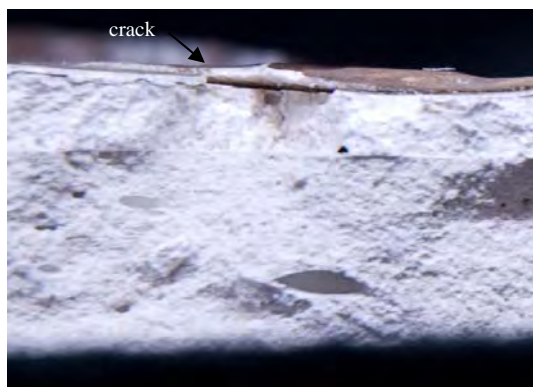
Image 6.
Mural mockup treated with Paraloid B72
tagged with Evident T2 Evi Dot™ Maple Red-
Orange under halogen light.
100x magnification

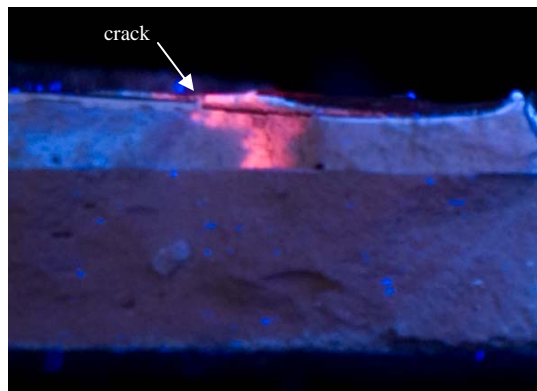
Image 7.
Mural mockup treated with Paraloid B72
tagged with Evident T2 Evi Dot™ Maple Red-
Orange under 350nm UV light.

The fluorescing nanoparticles revealed the path of the Paraloid B72. It traveled through the crack, through and under the lifting gesso layer and into the fine plaster layer. The consolidant was drawn into the surrounding friable material by capillary action.

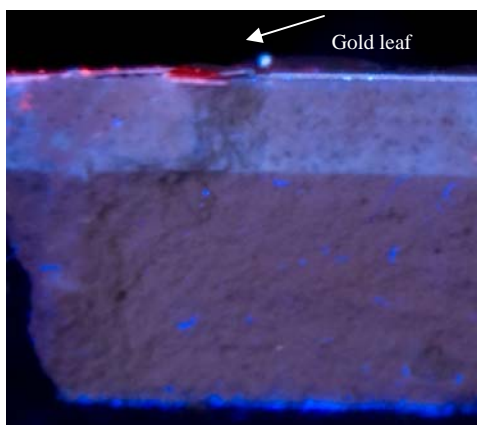
Image 8.
Mural mockup treated with Paraloid B72
tagged with Evident T2 Evi Dot™ Maple
Red-Orange under 350nm UV light
100x magnification

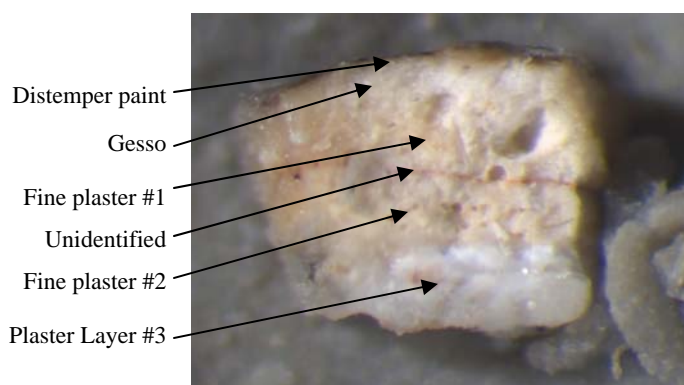
Image 9.
Mural sample S-E1 under halogen light
300x magnification.

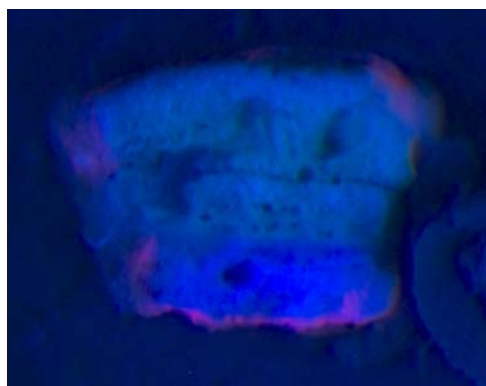
Image 10.
Mural sample S-E1 under 325nm UV light
300x magnification.

This sample was immersed in isinglass tagged with Sun Innovation™ YVE1005 (1 µl of nanoparticles in 1ml of consolidant solution). The sample was allowed to dwell in the solution for over an hour with frequent agitation to encourage penetration of the consolidant. The sample was then removed from the consolidant and allowed to dry. A crosssection of the sample was taken and examined under uv light. The nanoparticles revealed that the isinglass was completely unable to penetrate any of the layers of the samples.

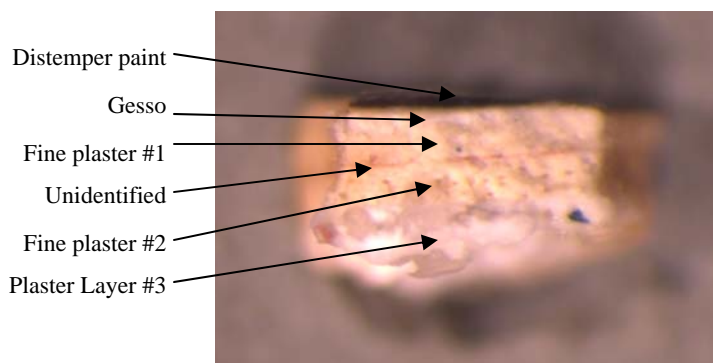
Image 11.
Mural sample S2 under halogen light
300x magnification.

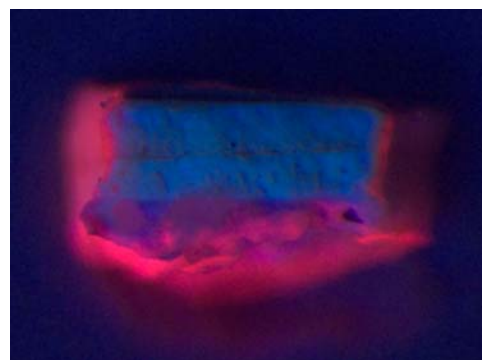
Image 12.
Mural sample S2 under 350nm UV light
300x magnification.

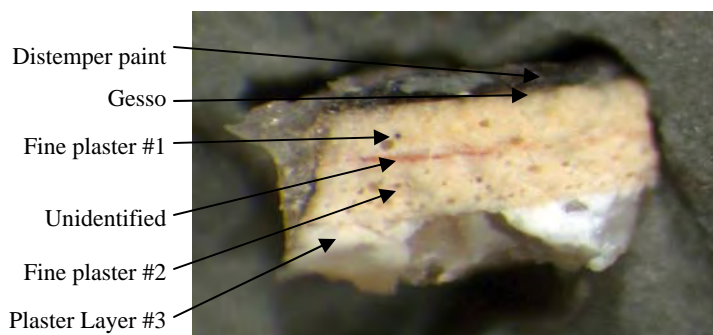
Image 13.
Mural sample S2 under halogen light
300x magnification.

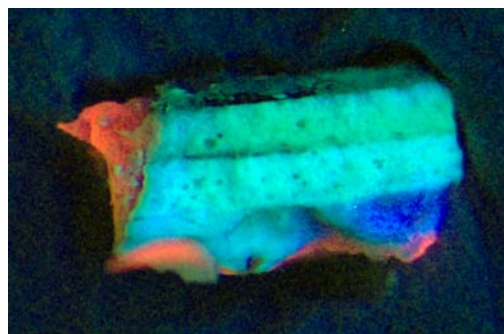
Image 14.
Mural sample S2 under 350nm UV light
300x magnification.

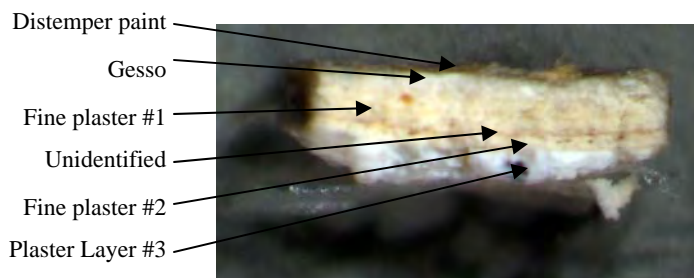
Image 15.
Mural sample S-N1 under halogen light
300x magnification.

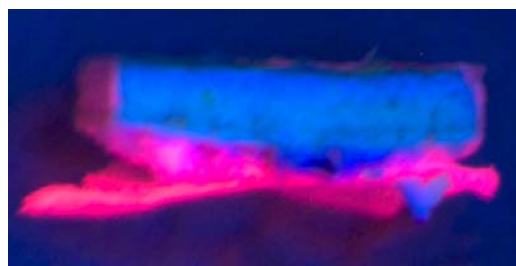
Image 16.
Mural sample S-N1 under 325nm UV light
300x magnification.

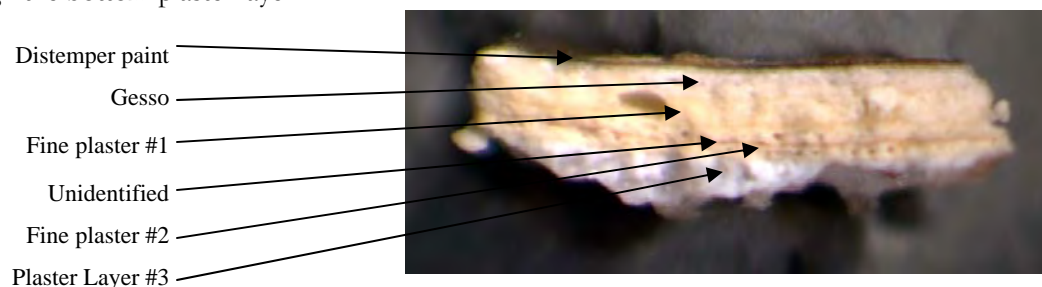
Image 17.
Mural sample S2 under halogen light
300x magnification.

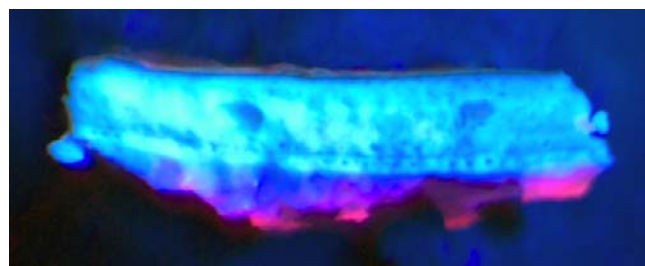
Image 18.
Mural sample S2 under 350nm UV light

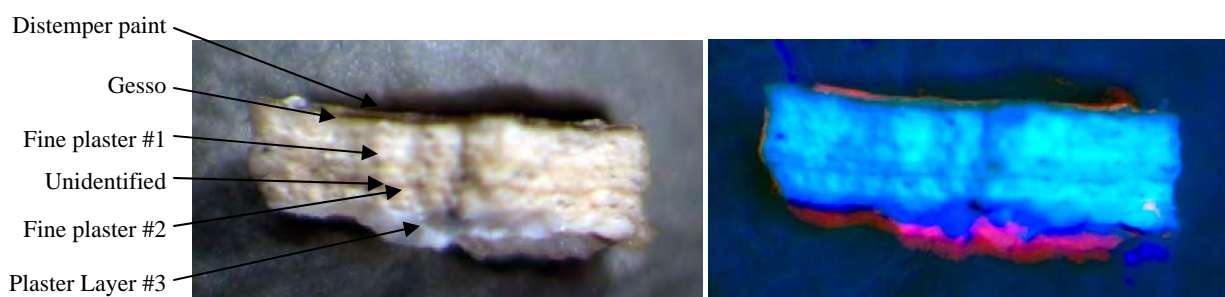
Image 19.
Mural sample S2 under halogen light
300x magnification.
